The root cause of a shaft crack

by **Don Silcock**
Bently Nevada Corporation

Shaft crack shuts down plant

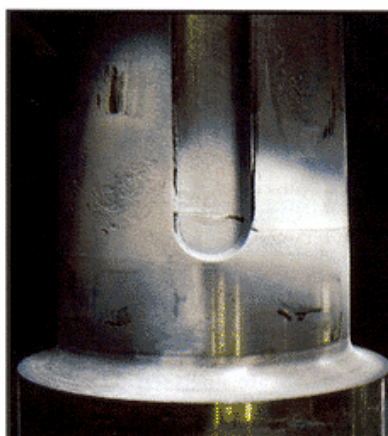
In October 1991, information from an online Bently Nevada Dynamic Data Manager® System suggested that a crack might be propagating on the input shaft of the speed increasing gearbox. Maintenance personnel advised that the syn gas compressor be shut down immediately, which stopped the ammonia plant and downstream production. Upon disassembly, maintenance technicians found that the input shaft coupling taper was cracked, 180 degrees around its circumference and through 55% of its diameter (see photo pg.21).

Incitec commissioned a failure analysis of the input shaft that included fractography, chemical analysis, metallurgical examination and hardness testing. Fractographic analysis of the damaged shaft showed that the crack had begun adjacent to the coupling taper keyway, where fretting and corrosion damage was evident. The crack had slowly spread, radially and against the direction of rotation, into the coupling taper keyway. Then, it reversed direction and spread rapidly in the direction of rotation. Failure analysis concluded that the shaft cracked due to fatigue.

A spare set of gears was installed, and the machine returned to service. The September 1992 issue of *Orbit* describes how the cracked shaft was detected, and the compressor saved.
